# STAR VALLEY RANCH

ARCHITECTURAL  
BUILDING ASSESSMENT  
and  
CODE ANALYSIS:

GAMBREL BARN & SILO

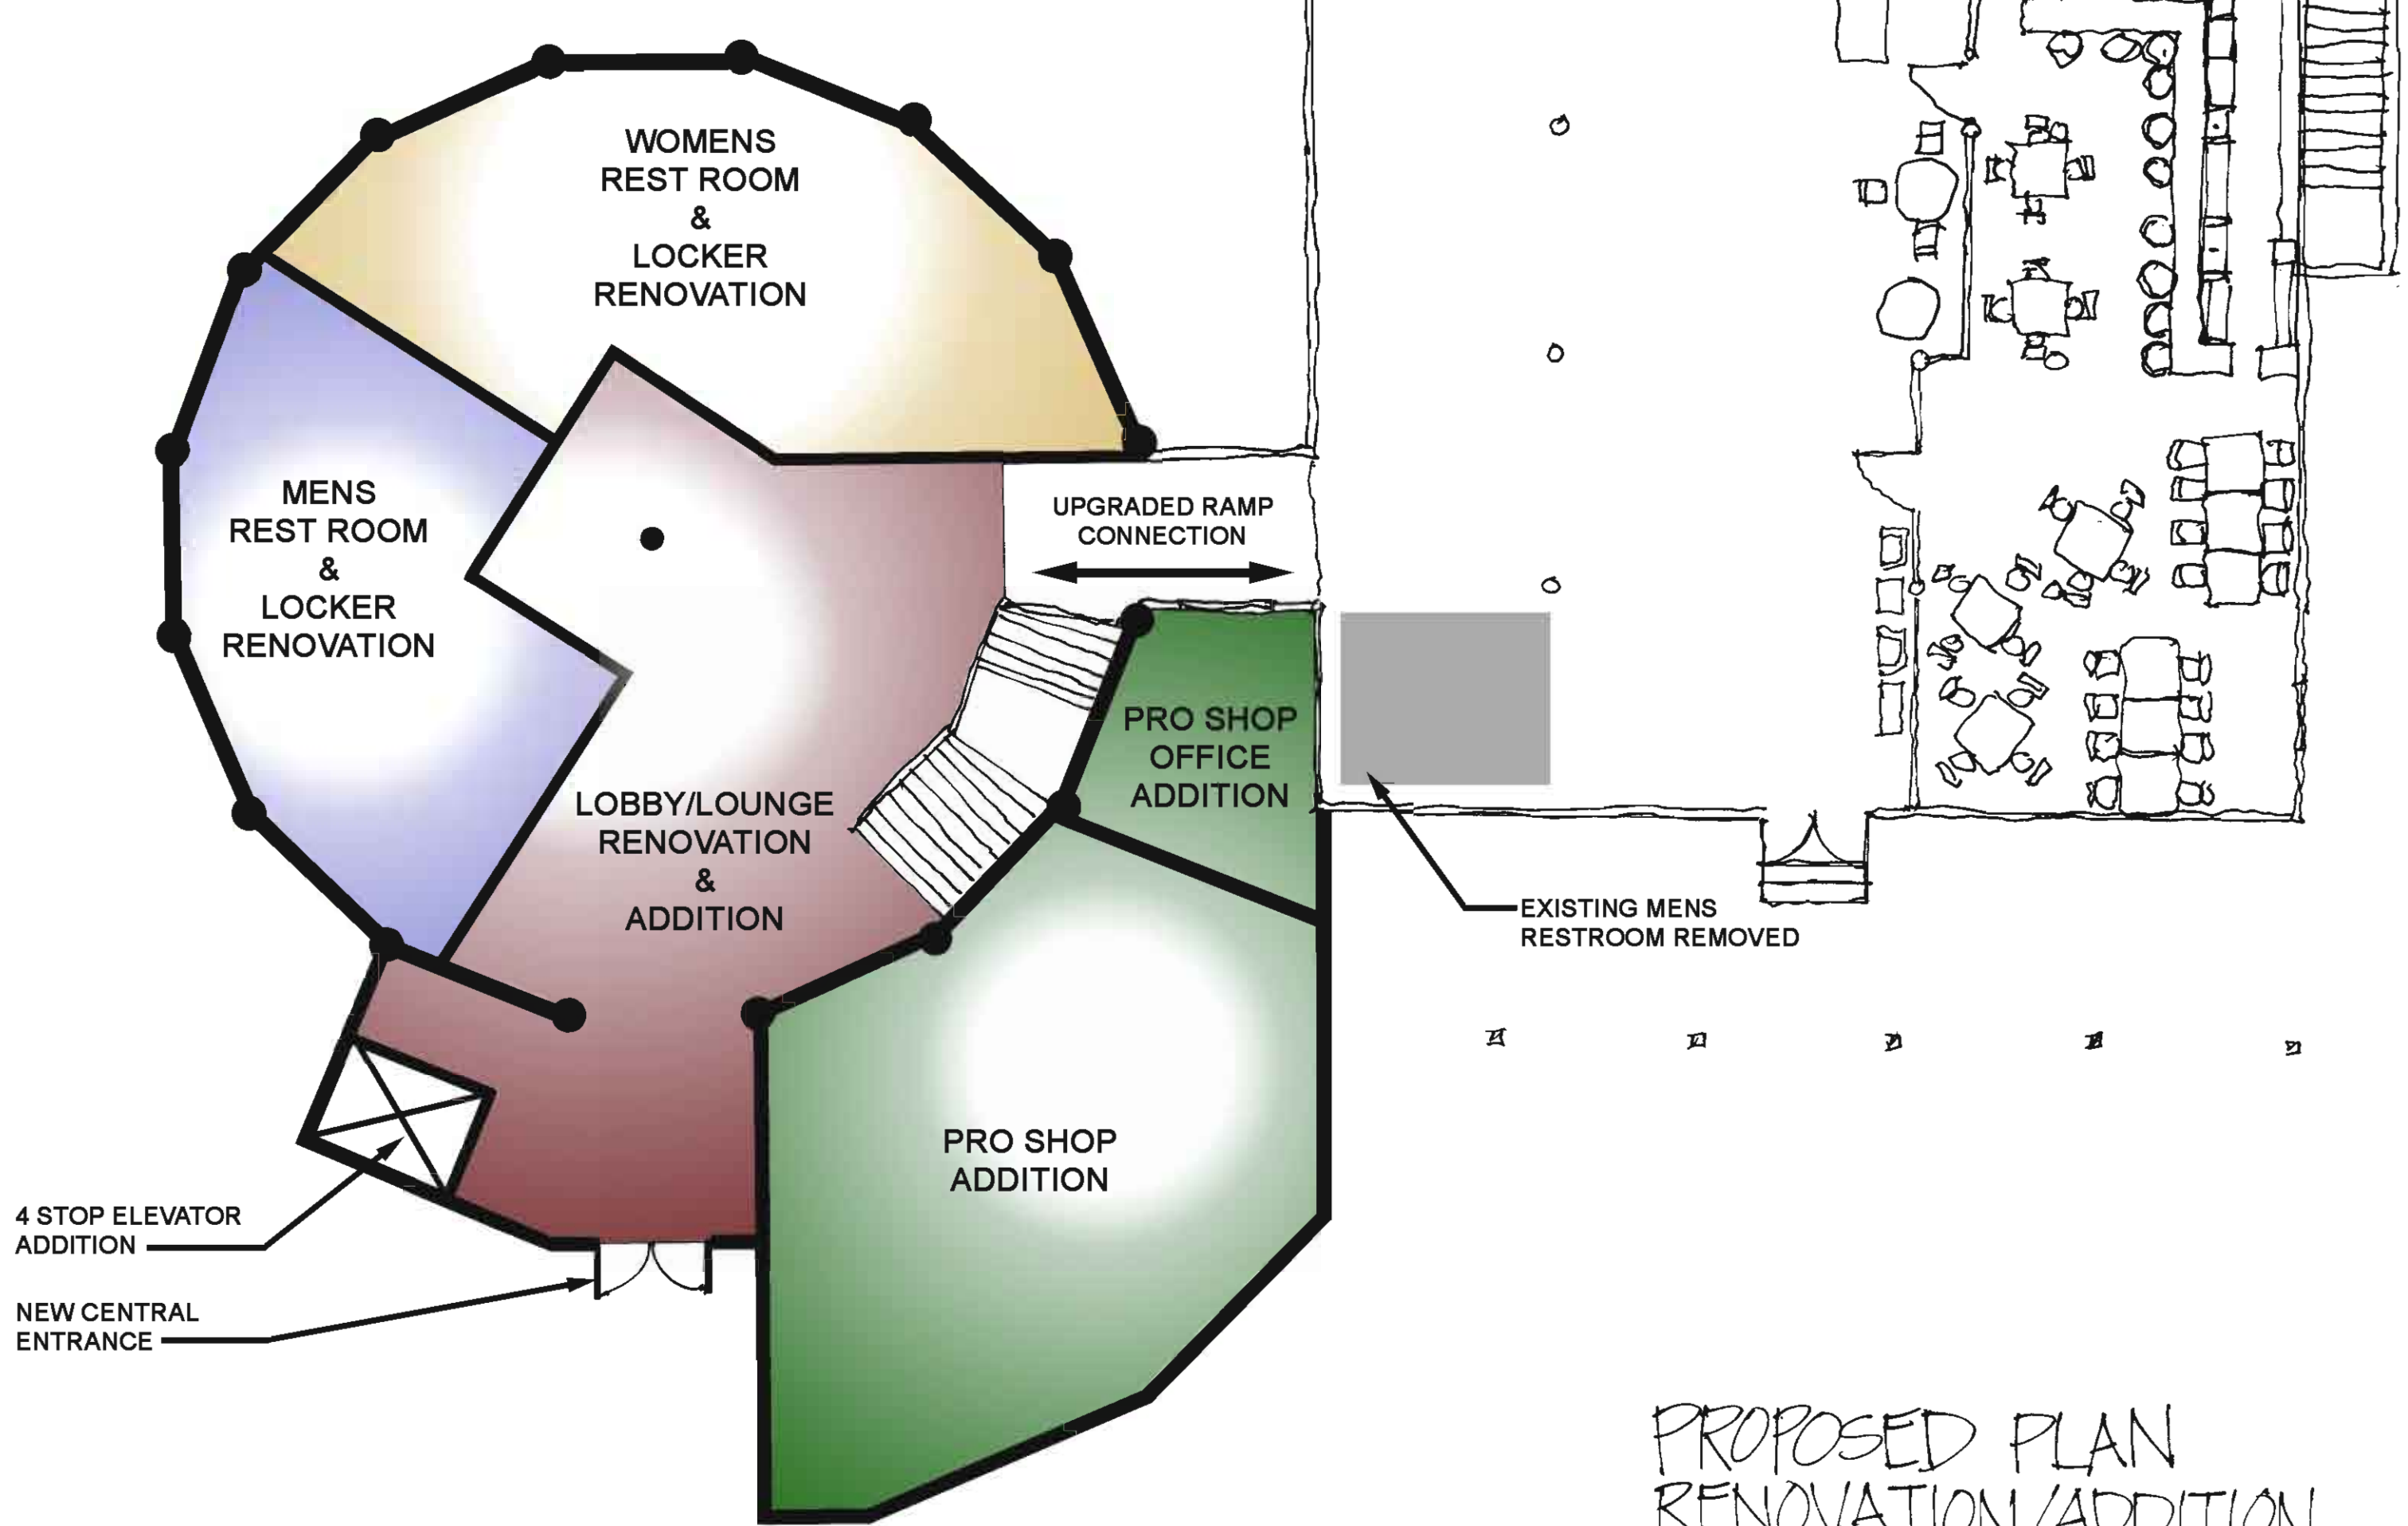
PROPOSED PLAN  
RENOVATION/ADDITION  
SCALE: 1/8"=1'-0"

4 STOP ELEVATOR  
ADDITION

NEW CENTRAL  
ENTRANCE

WOMENS  
REST ROOM  
&  
LOCKER  
RENOVATION

MENS  
REST ROOM  
&  
LOCKER  
RENOVATION

LOBBY/LOUNGE  
RENOVATION  
&  
ADDITION

UPGRADED RAMP  
CONNECTION

PRO SHOP  
OFFICE  
ADDITION

PRO SHOP  
ADDITION

EXISTING MENS  
RESTROOM  
REMOVED

- Remodeling work in the silo will provide necessary space for an ADA compliant ramp at this connection. This remodeling will also better integrate the silo-barn connection with a main entrance and central lobby.

- Renovation of Men's restroom
  - Remodeling work in the silo will provide conveniently located and upgraded restrooms that meet all code requirements. Upgraded restrooms will include space for lockers and benches. The renovation includes the demolition of the existing mens rest room in the barn building.

- If the committee elects to repair the interior stair, it is recommended that a new, centrally located stair integrated with an elevator be constructed and the existing stair be demolished. The proposed pro shop office in the attached schematic plan is one possible location.
